# **Rose State College**

## **ADA Transition Plan Update**

**May 2018**

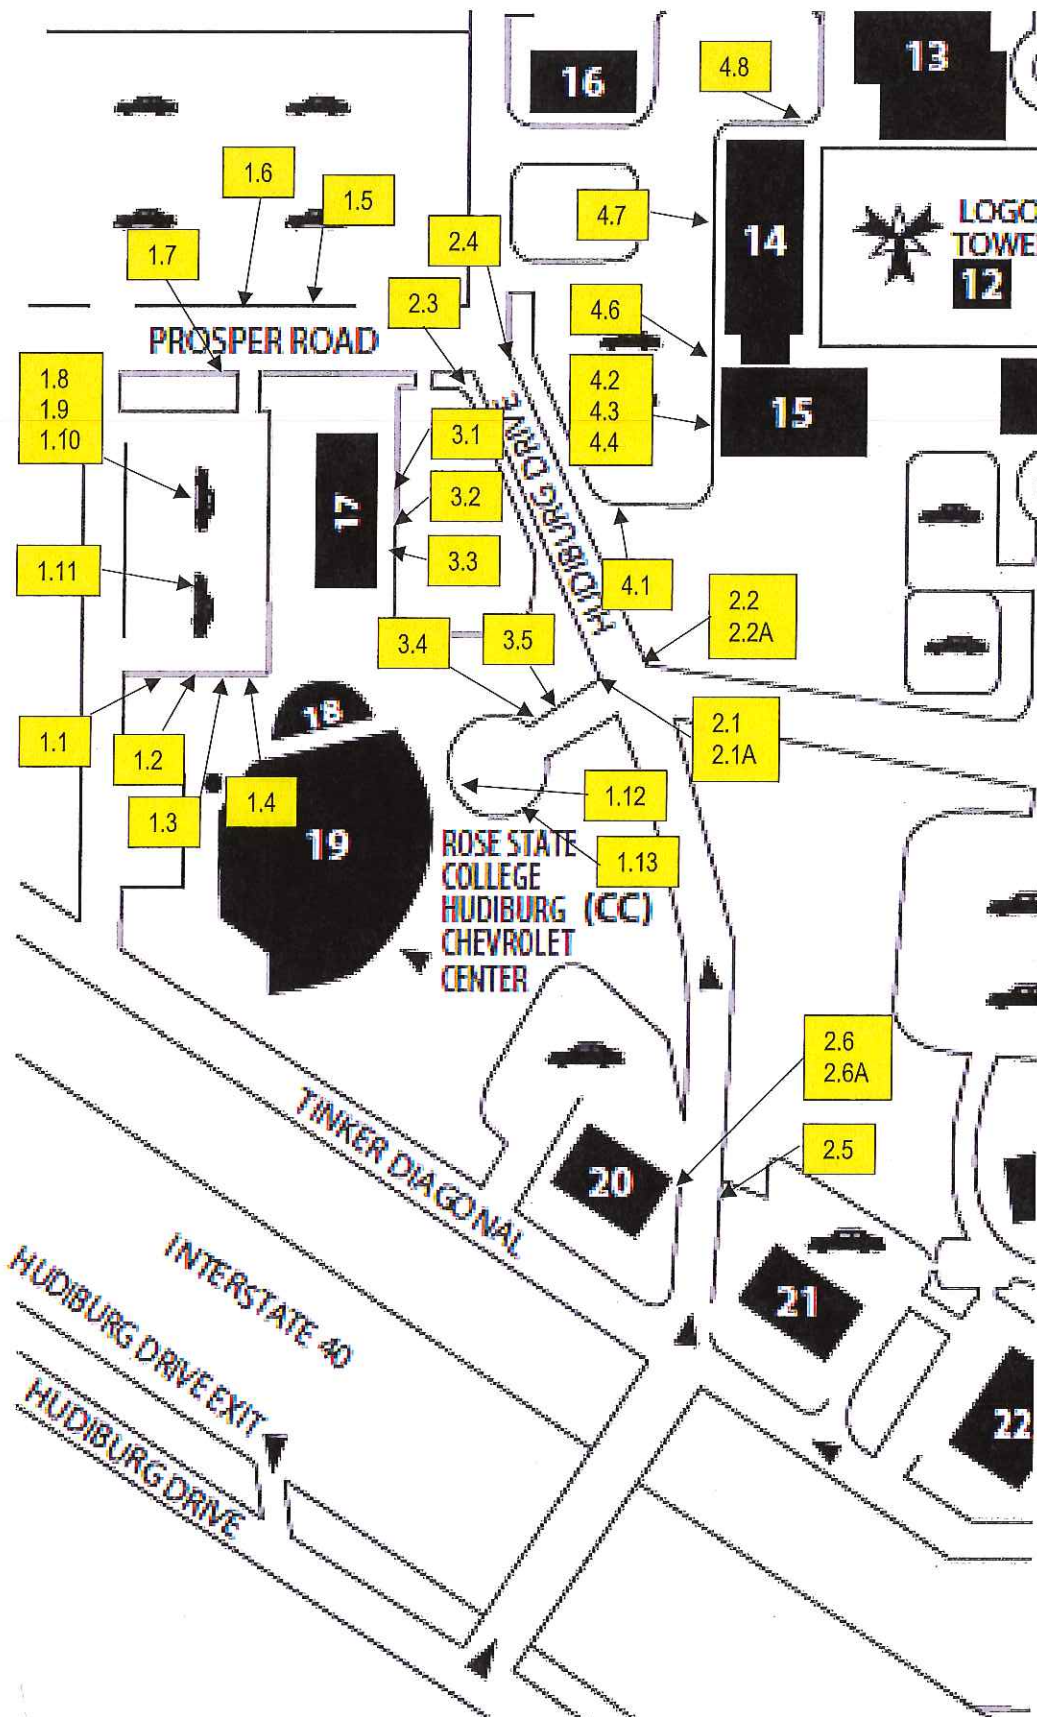
## Curb Ramp Assessment – West Campus

| Ramp # | | Perpendicular Curb Ramp | | | | Gutter Slope | Counter Slope | Landing | | | Parallel Ramp - Left or Single | | | Parallel Ramp - Right | | | Tactile Warning |
|---|---|---|---|---|---|---|---|---|---|---|---|---|---|---|---|---|---|
| Note: Ramp projects into driving lane/ relocate ramp to the west of existing location. | | | | | | | | | | | | | | | | | |

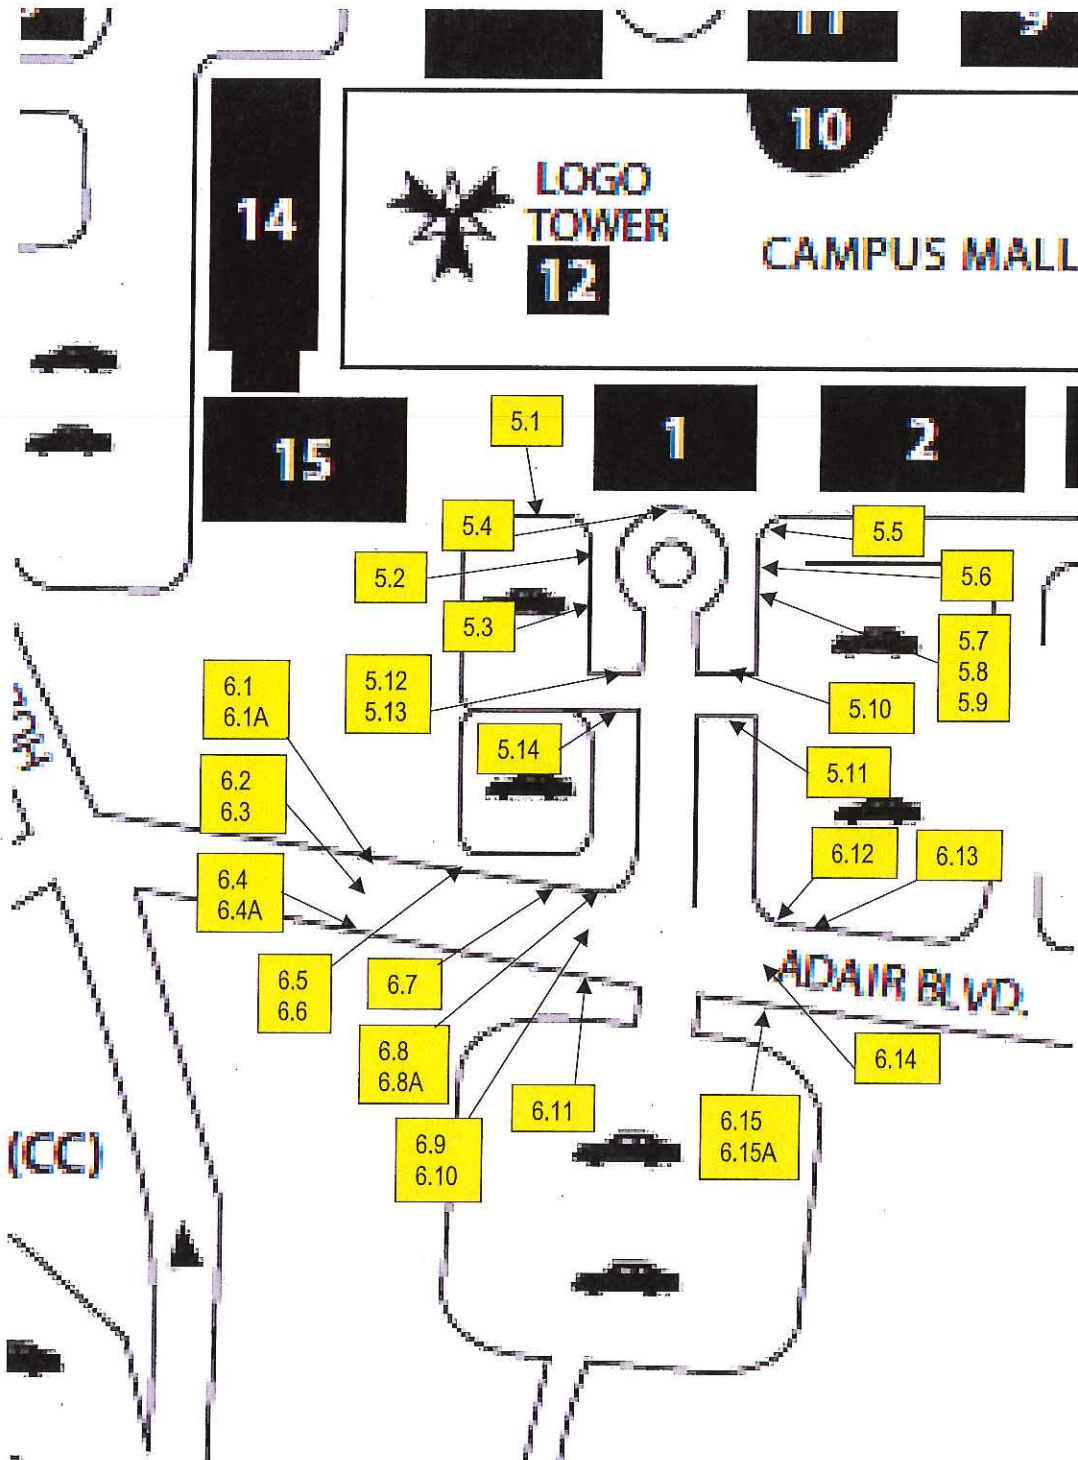
## Curb Ramp Assessment – Administration Building

| Notes: No ramp at end of SW. Install parallel ramp | | | | | | | | | | | | |

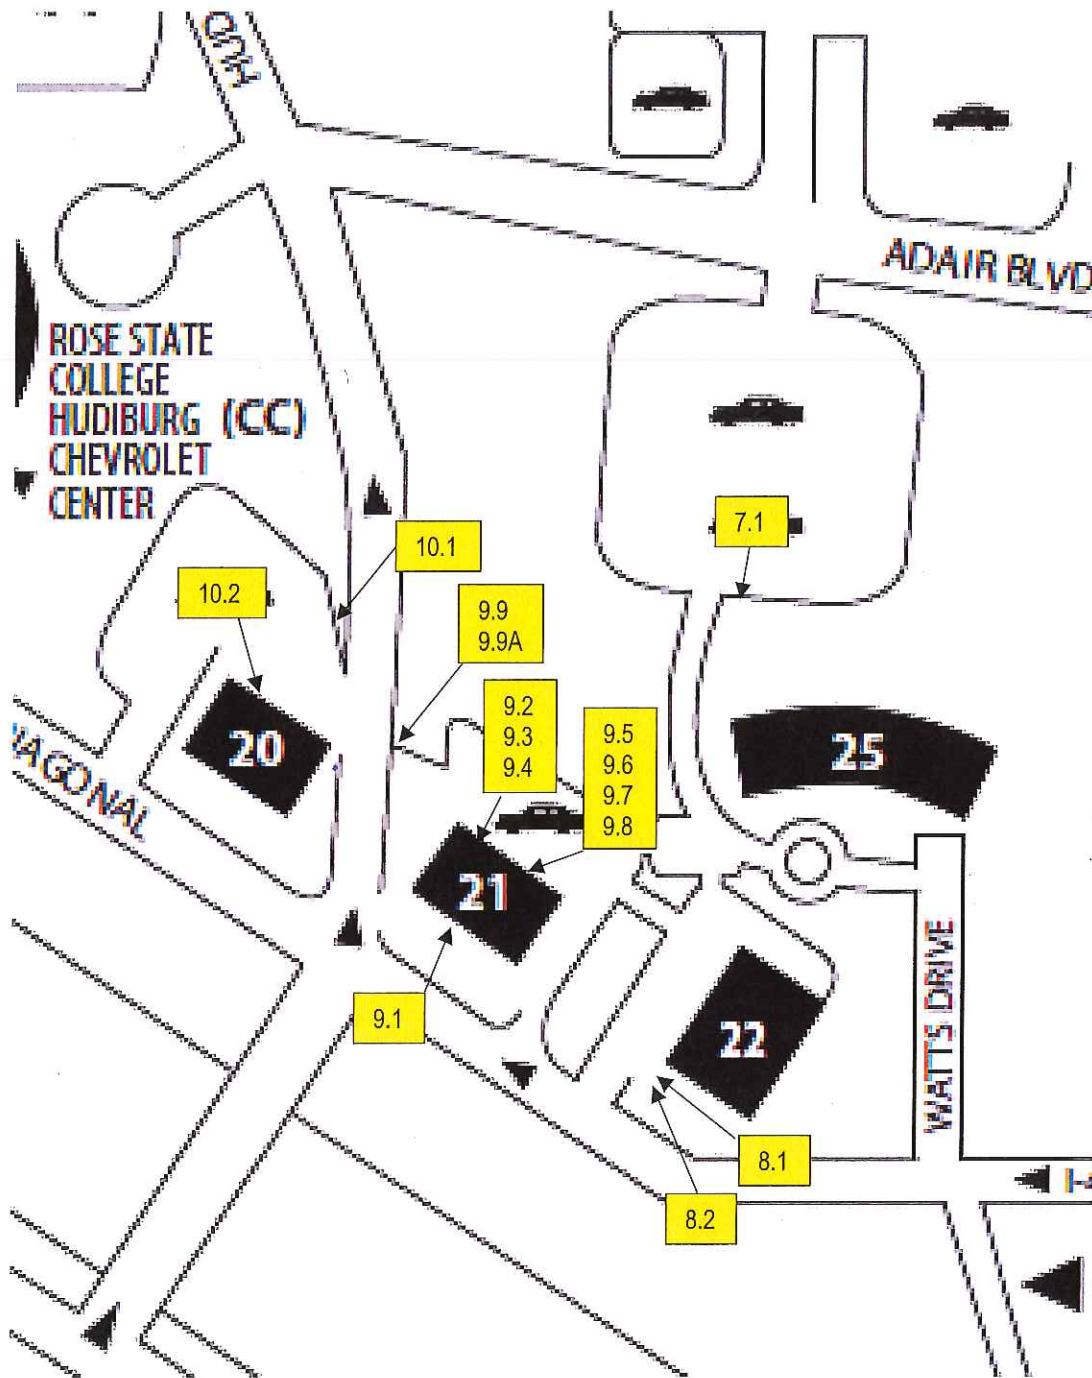
## Curb Ramp Assessment – Southwest Campus

| Notes: Landing running slope excessive, no tactile warnings. | | | | | | | | | | | | |

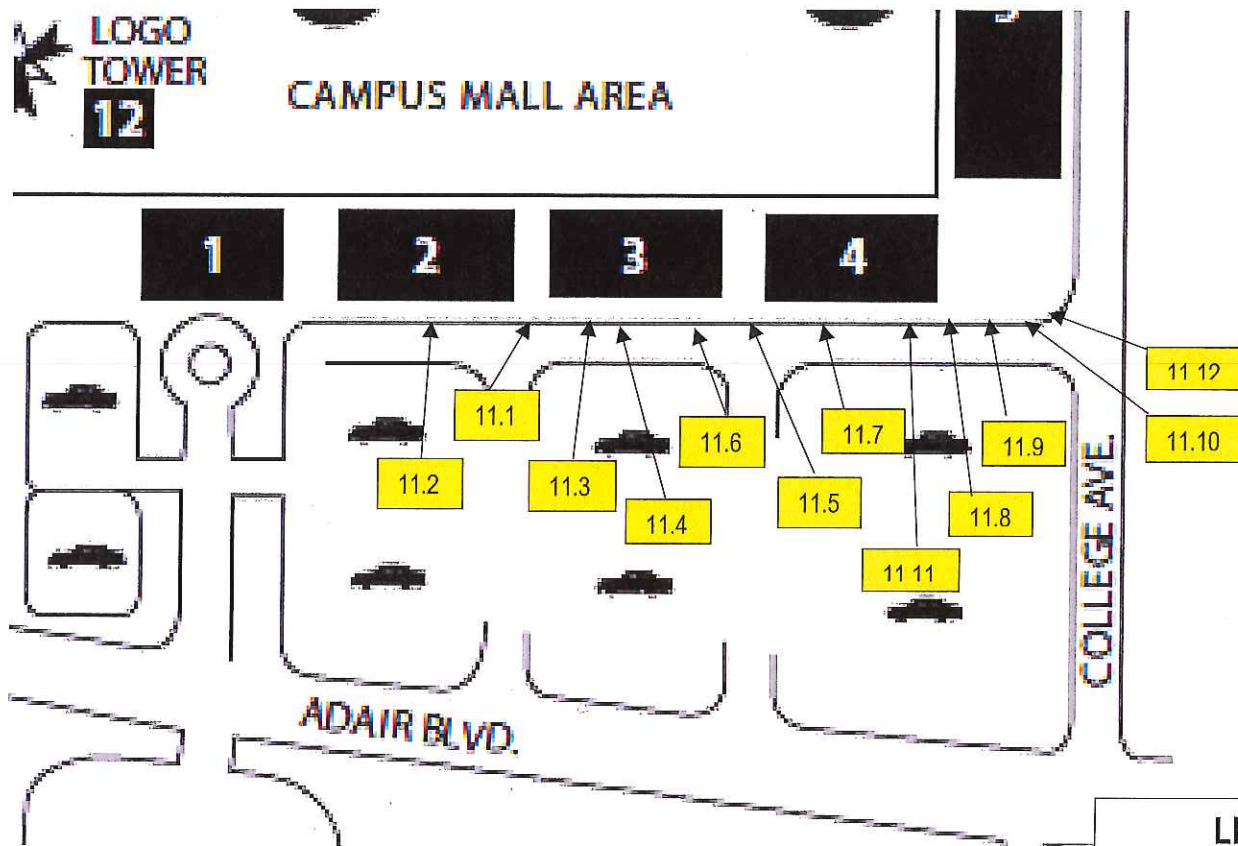
## Curb Ramp Assessment – Southeast Campus

| Note: Landing cross slope excessive, no tactile warnings | | | | | | | | | | | |

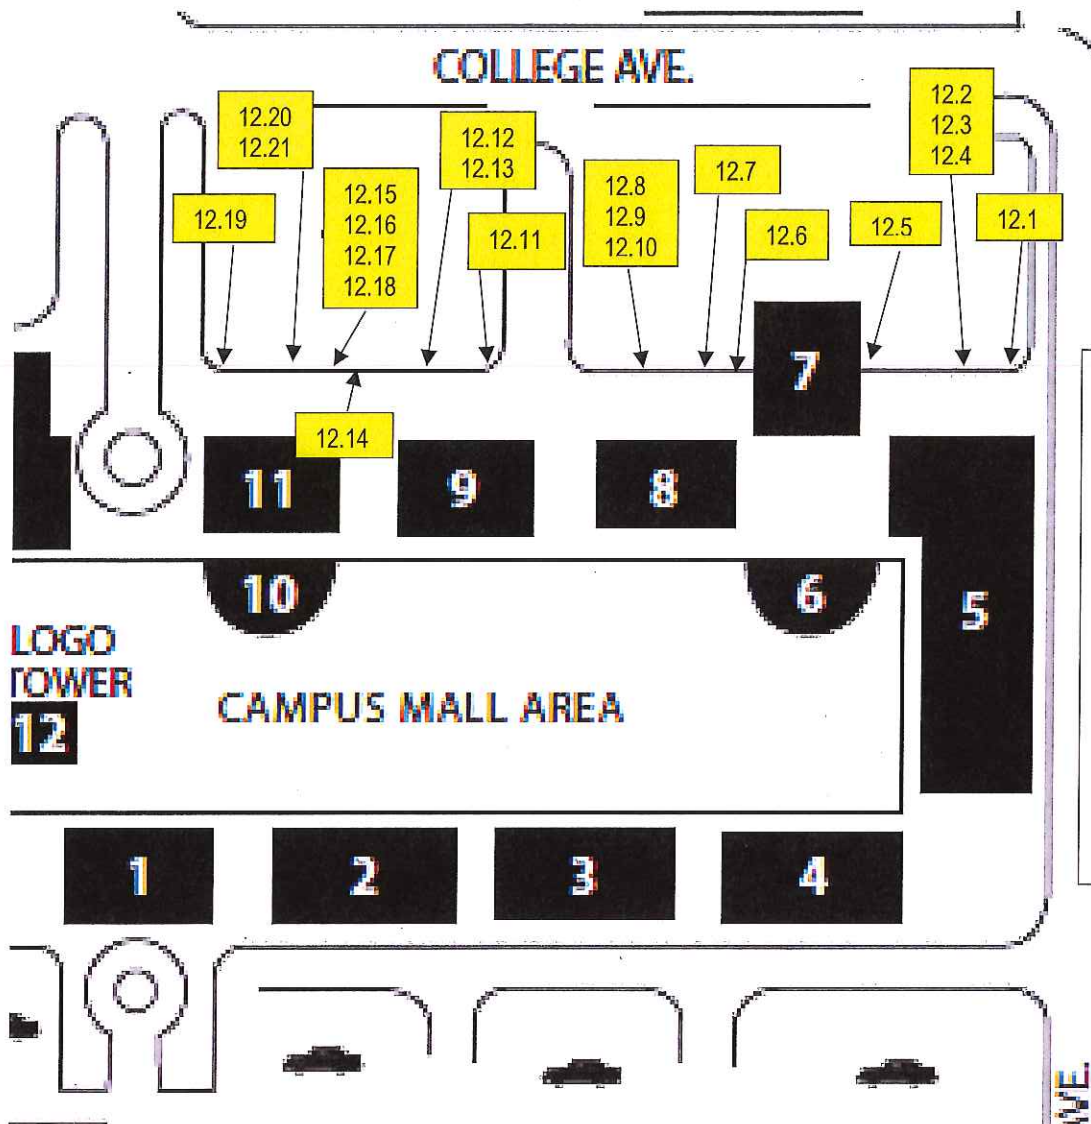
## Curb Ramp Assessment – Northeast Campus

| Notes: No ramp or access aisle at accessible parking spaces | | | | | | | | | | |
|---|---|---|---|---|---|---|---|---|---|---|
| Notes: No ramp or access aisle at accessible parking spaces | | | | | | | | | | |

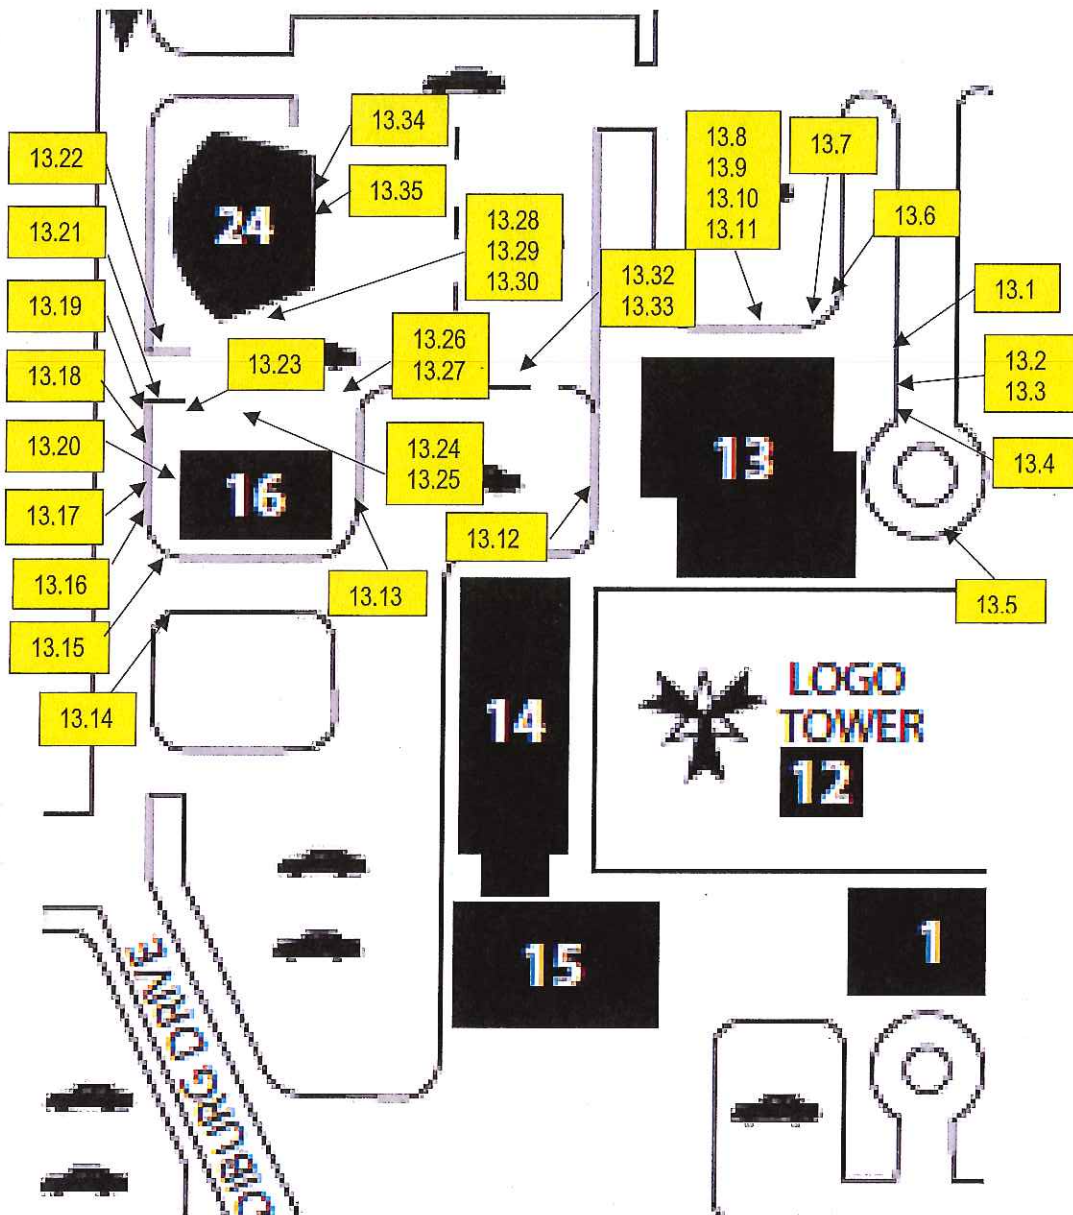
## Curb Ramp Assessment – Northwest Campus

| Notes: No landing | | | | | | | | | | | |

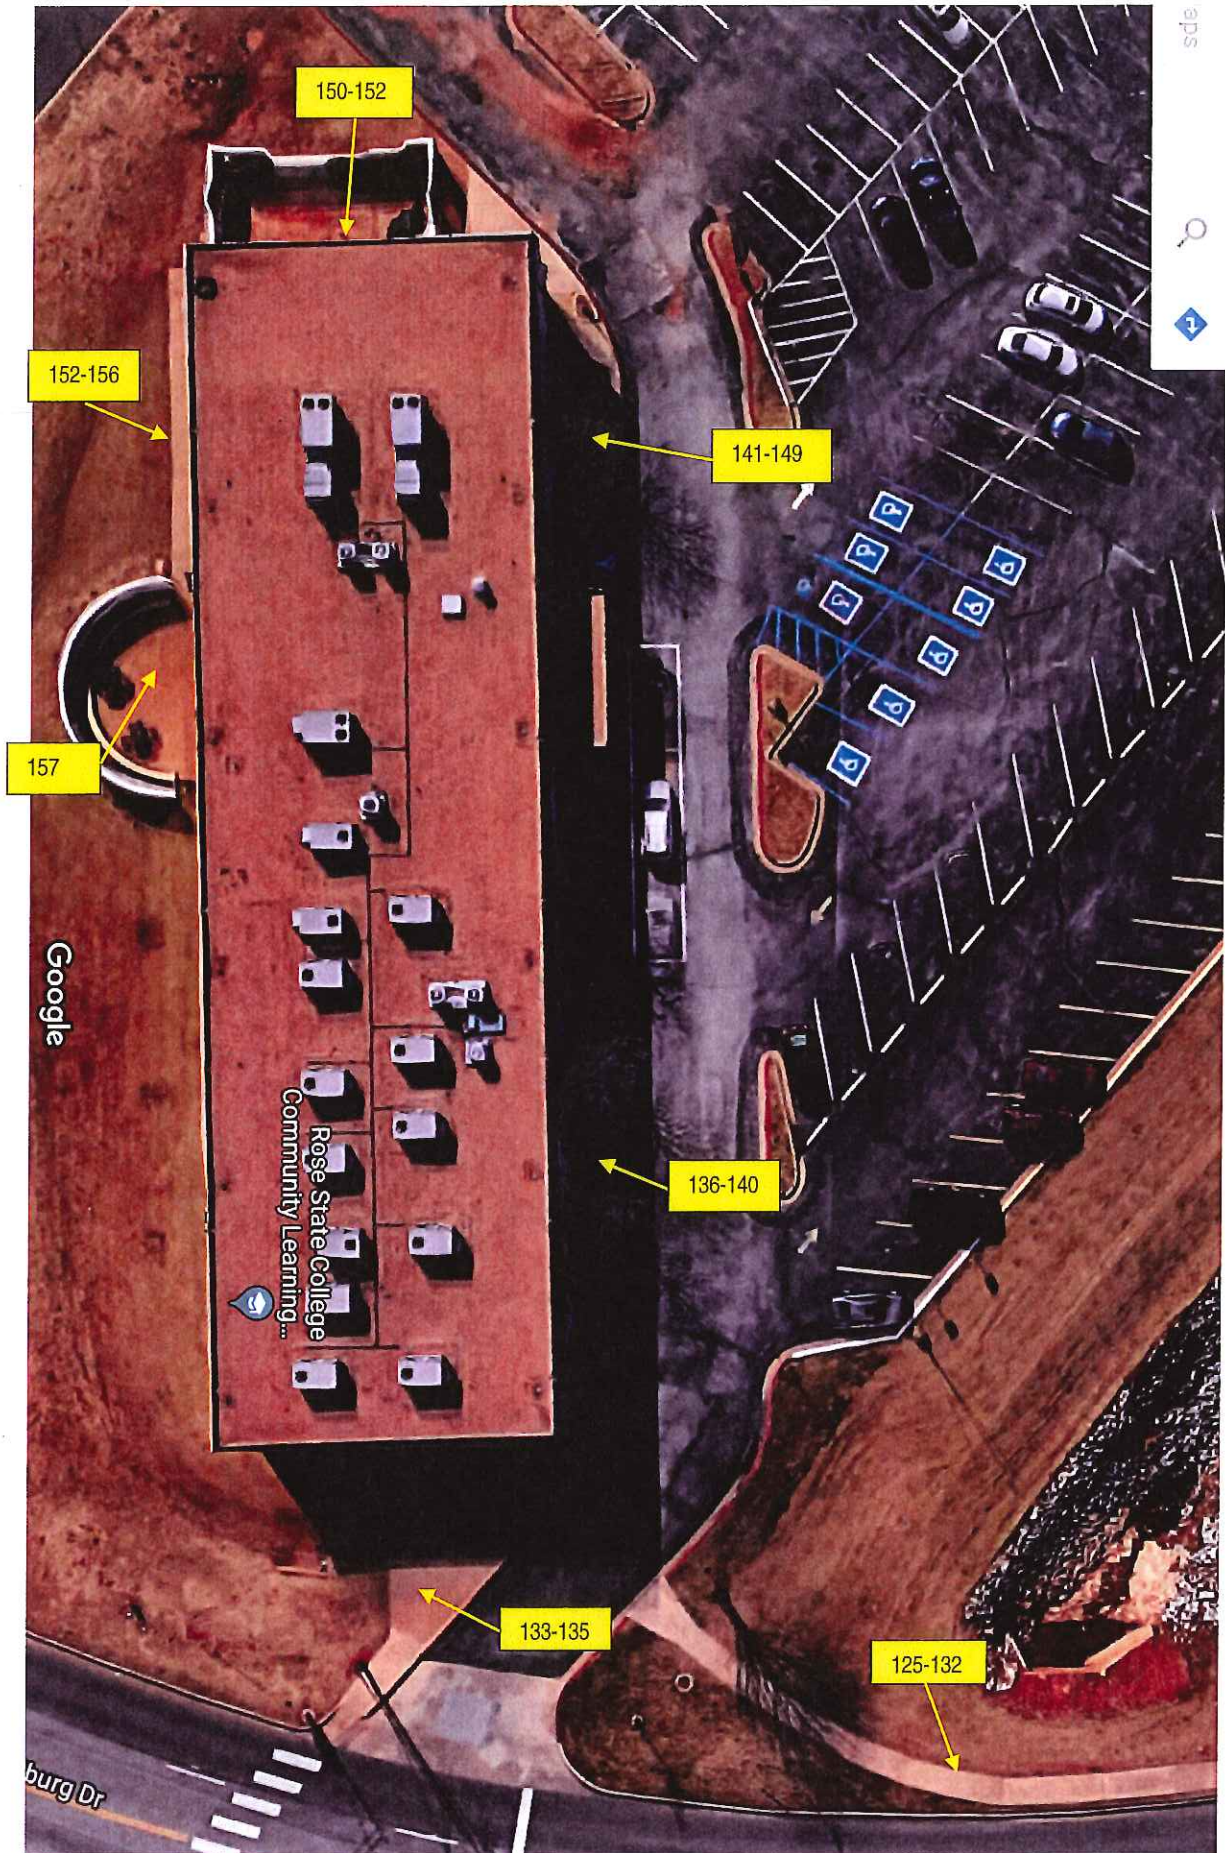
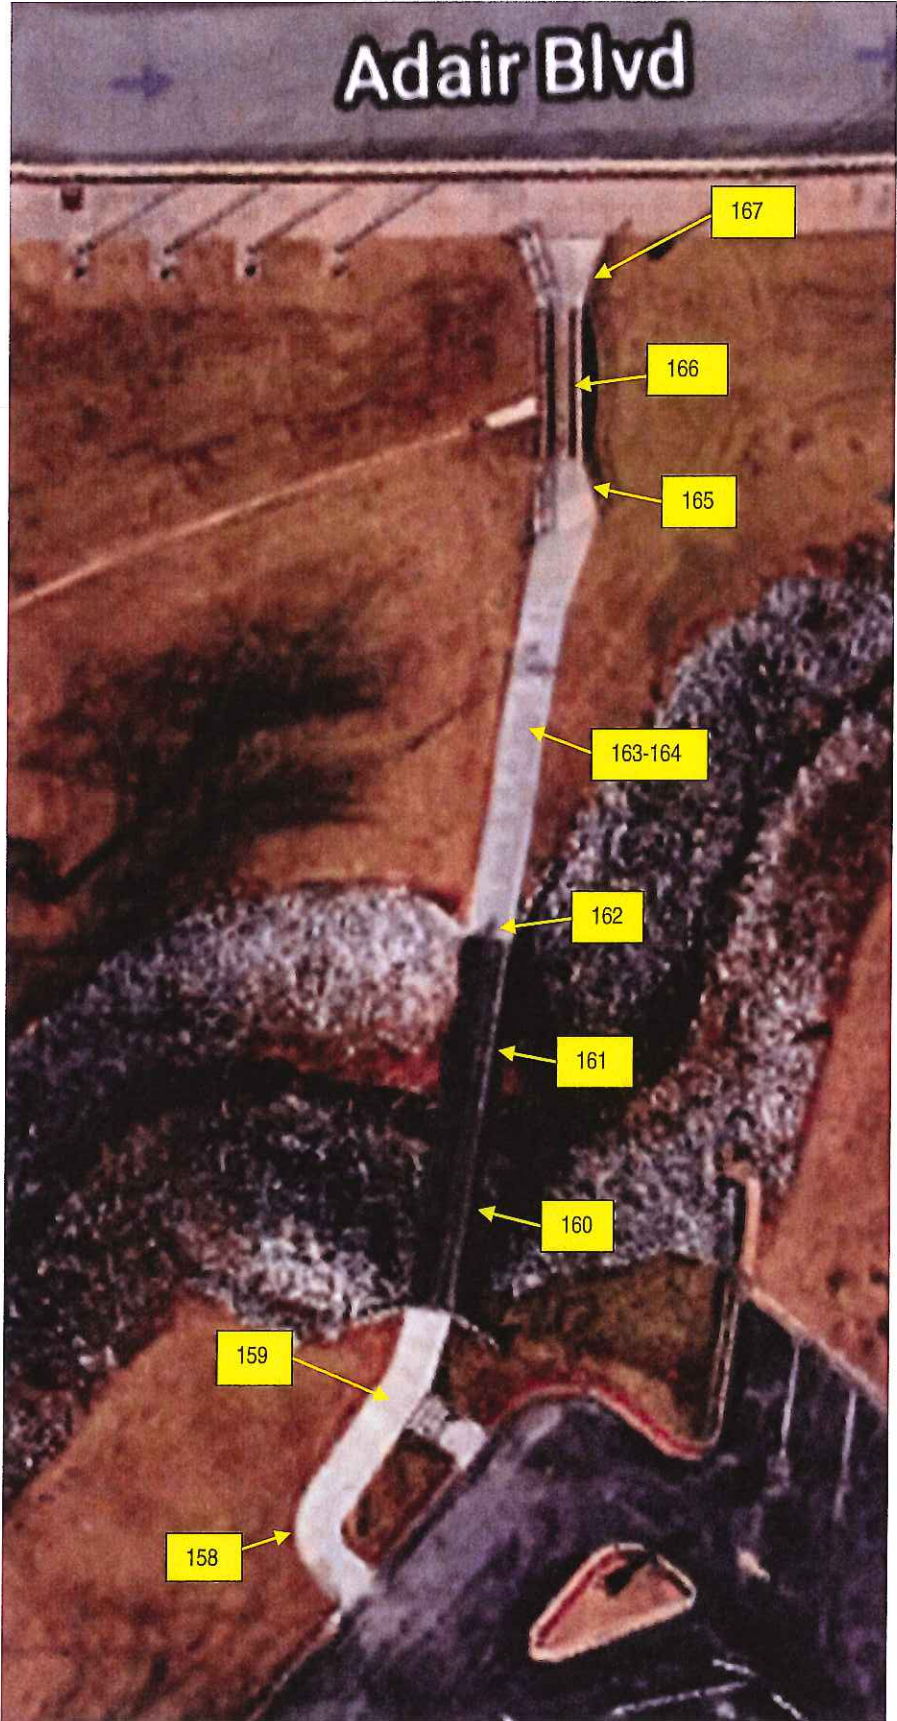
# Community Learning Center (1)

| Note: Bridge approach excessive running slope | | | | | | | | | | |

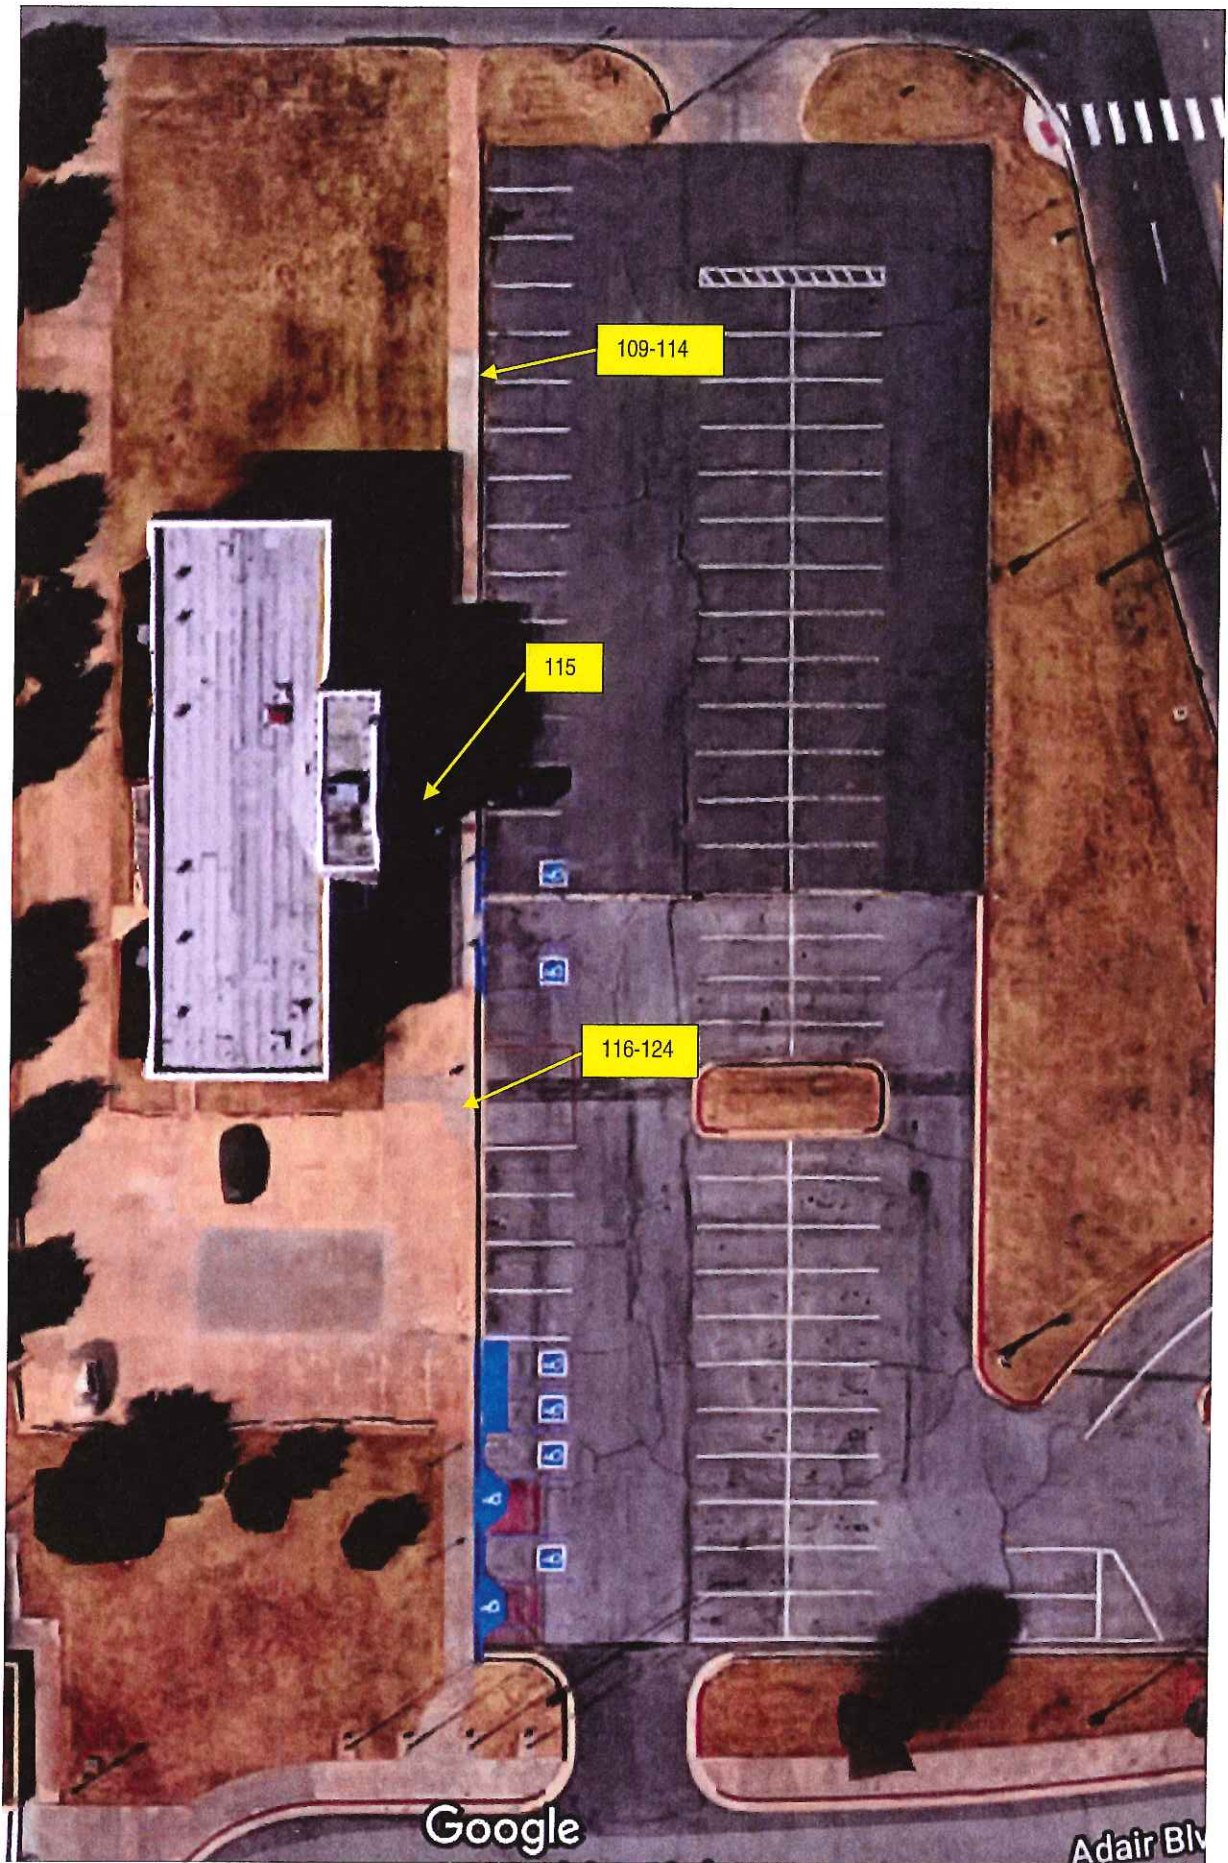
UCO Building

| Note: Running slope controlled by Parking Lot Grade | | | | | | | | | |
